REPORT ON THE CREW OVERBOARD INCIDENTS AND FATALITY ON MONTEREY BAY (MORPHEUS), 3/13/2019

JULY, 2019

Morpheus Working Party Report

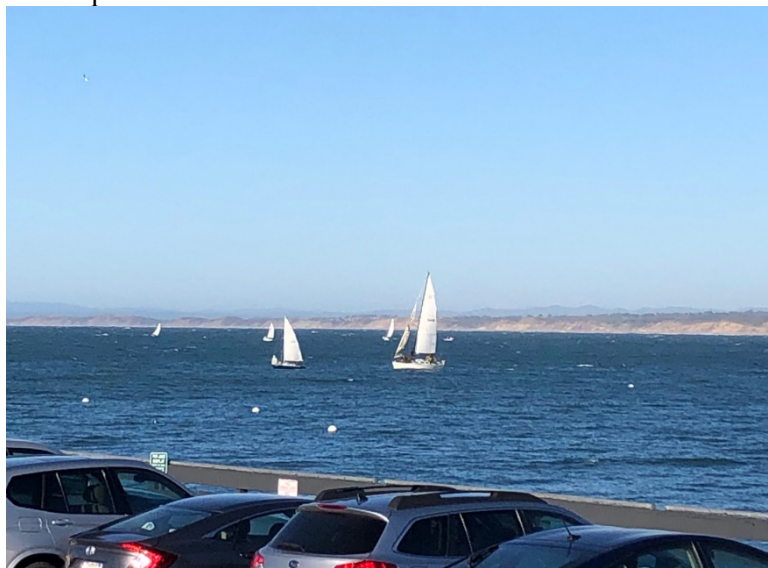
Morpheus, seen from clubhouse, March 13, 17:50

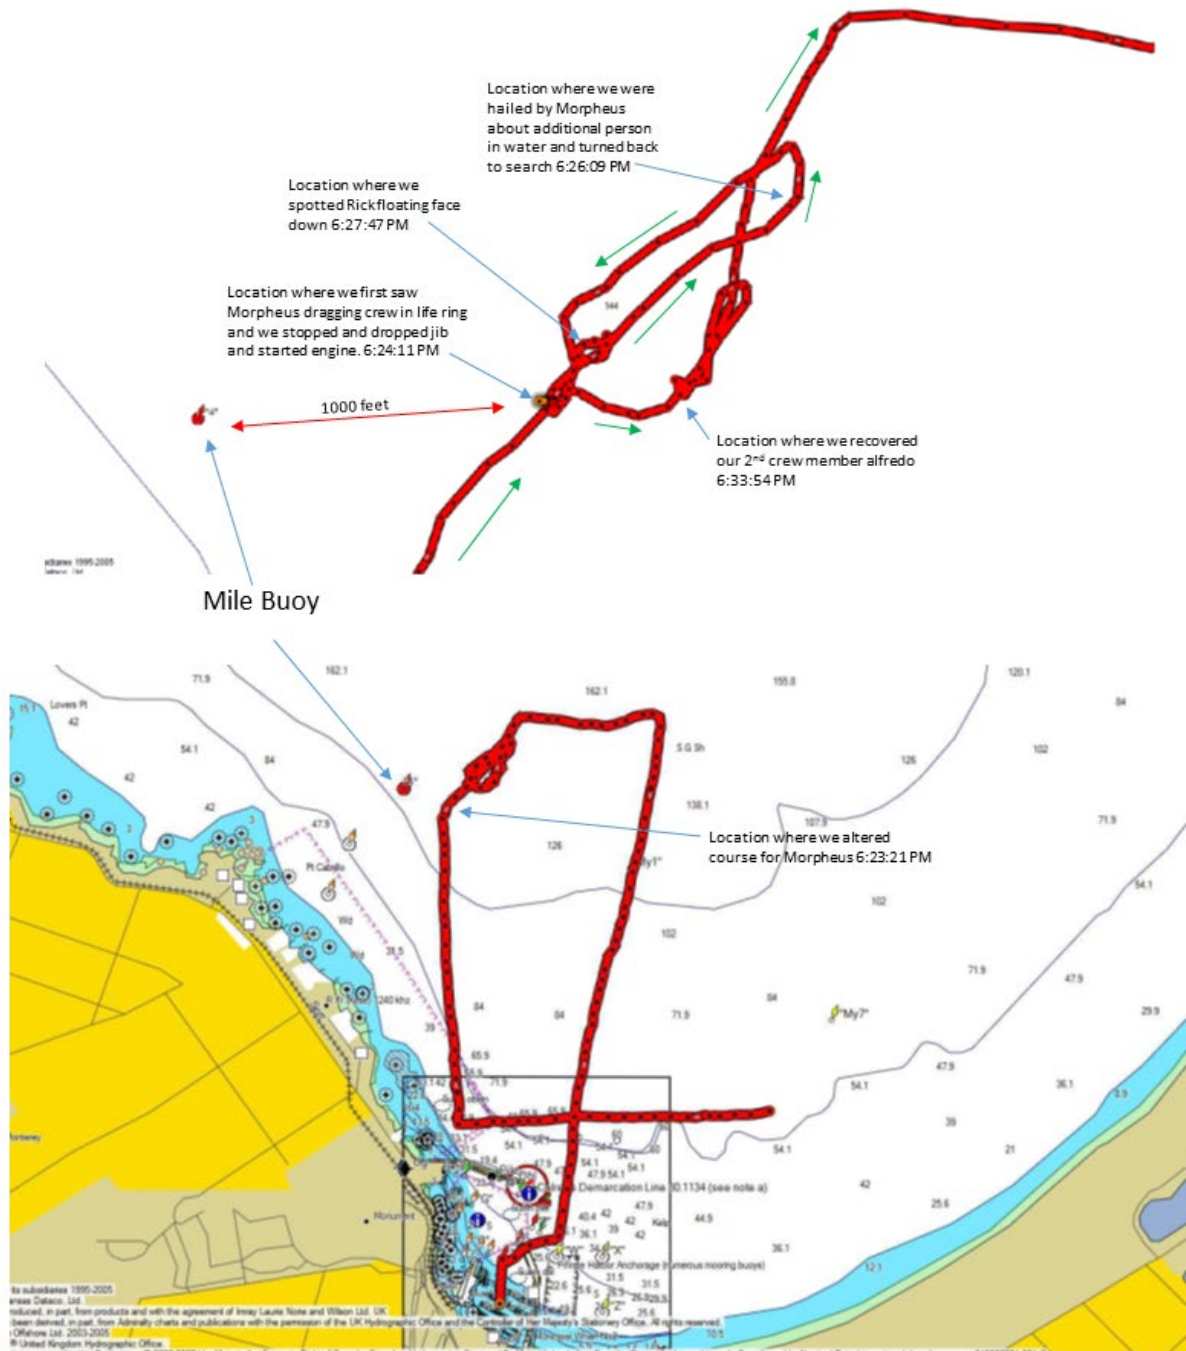
GPS Track and Notes of Loca Motion 3/13/19

Top, Close-up of the track during rescue attempt. Below, *LocaMotion's* track that day

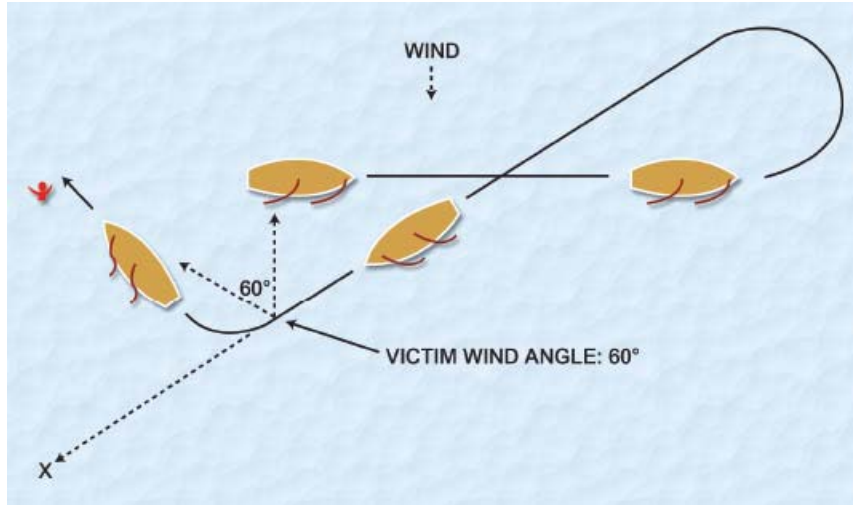
Ideal Figure 8 recovery diagram per US Sailing

Ideally, one approaches a person in the water on a close reach (about 60 degrees off the wind),

controlling speed by luffing the sails and adjusting course as needed for a safe approach. Both the Quickstop and Figure-8 maneuvers are classically describe as concluding with that approach. In the weather conditions, and with Jeff describing himself as a little “rusty” on the feel of the boat, he was not able to accomplish this maneuver on his first try.
